# Detectable faults on recently installed solar modules in Western Australia

Sinisa Djordjevic\*, David Parlevliet, Philip Jennings

School of Engineering and Information Technology

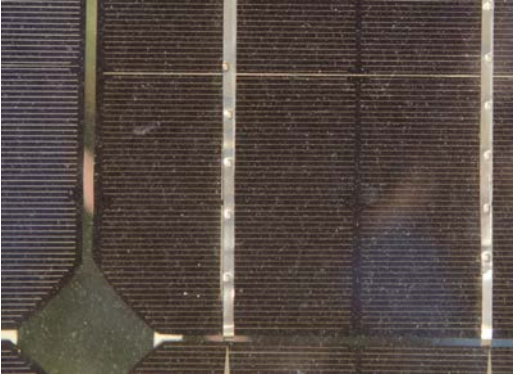
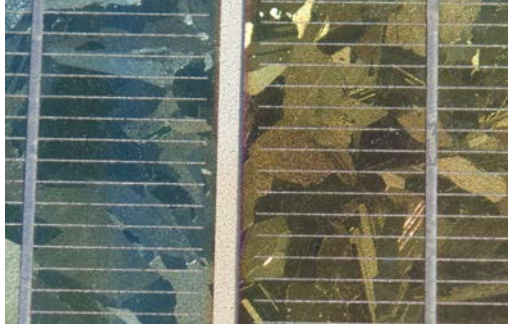
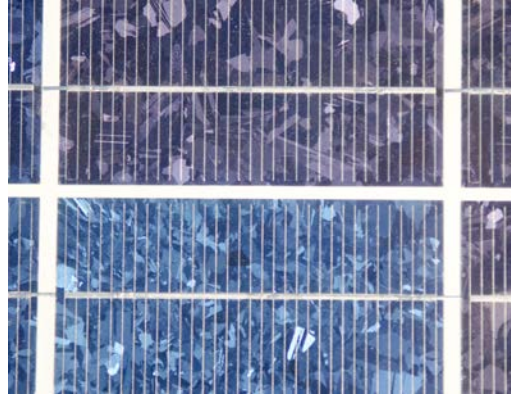
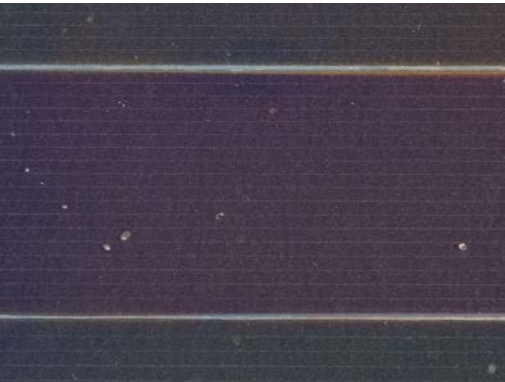
Visual discolouration is the most common defect in modules that have been weathered in the field for many years. This is evident in crystalline, multicrystalline and amorphous silicon modules as can be seen in Table 1 (1.1–1.4). Discolouration reduces the sunlight that penetrates to the solar cell.

The discolouration is likely caused by internal factors (poor encapsulant quality) or external ones (high temperature, humidity).

| <p>1.1 Discoloured solar cells – yellowish (c-Si)</p> | <p>1.2 Discoloured solar cells – yellowish (p-Si)</p> | <p>1.3 Discoloured solar cells – purple (p-Si)</p> |
| <p>1.4 Discoloured solar cells – purple (a-Si)</p> | <p>1.5 Cracking of solar cells (c-Si)</p> | <p>1.6 Cracking of solar cells (a-Si)</p> |

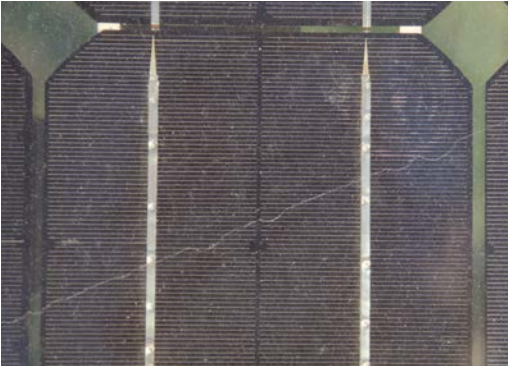
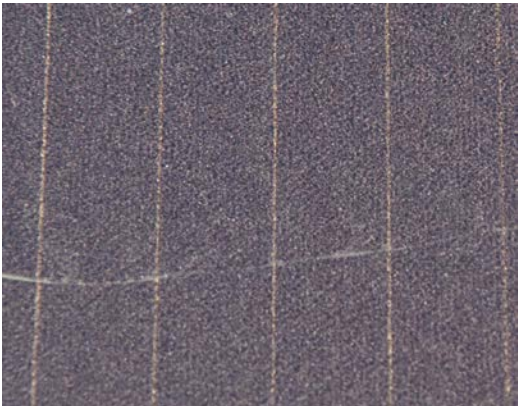
Cracks can be visually identified, if they are large enough. Micro-cracks can be formed during manufacturing, in manual soldering, for example, when mechanical and thermal stress is applied. Under further stress, after years in the field, those cracks can become larger and more obvious for visual detection. Electroluminescence imaging detects micro-cracks very well. Cracks of solar cells can reduce the module output. Examples are given in Table 1 (1.5, 1.6).

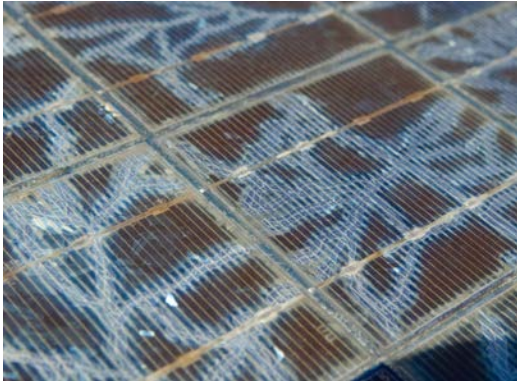
This is a relatively new phenomenon, described as discolouring of the silver grid across the cell or along the edge. It has been found that snail tracks do not emerge in modules that are stored indoors; they appear after 3–5 months of outdoor exposure. Snail tracks develop to a certain width and seem not to (or maybe very slowly) grow any further. The degree of EVA cross linking does not correlate with snail tracks, and snail tracks make cell cracks “visible”. The origin of snail tracks is still a matter of speculation [18]. An example is shown in Table 1 (1.7).

1.7 Snail trails

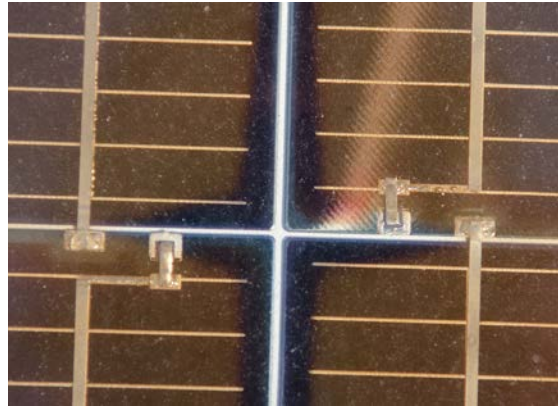
1.8 Solar cell edge degradation and discoloration

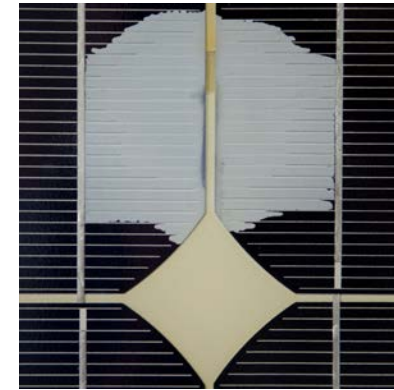
1.9 Encapsulant delamination (c-Si)

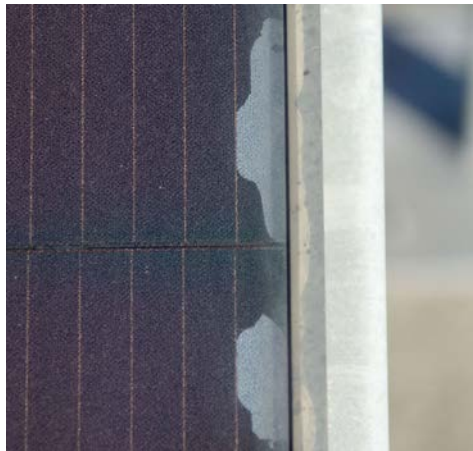
1.10 Encapsulant delamination (a-Si)

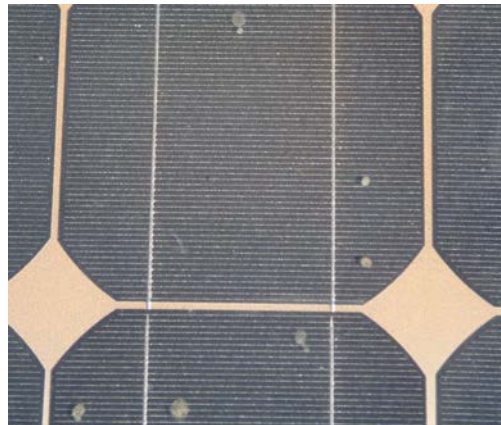
1.11 Front surface soiling

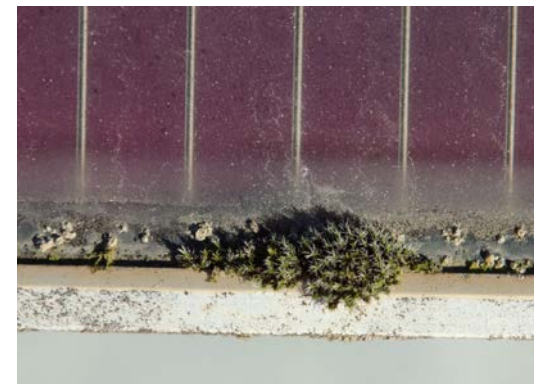
Soiling is a form of shading that can decrease the module's performance over time and has been well documented with respect to dust concentration, wavelength and spectral transmittance [20]. Soiling consists of aggregated dust, grime, bird droppings and even moss in some situations (Table 1: 1.12). If soiling extends far enough to cover a portion of the cells, the output current is reduced, as can be seen in the I–V curve [21].

1.12 Blackening at the bottom edge of the module (ingrained dirt not possible to remove)

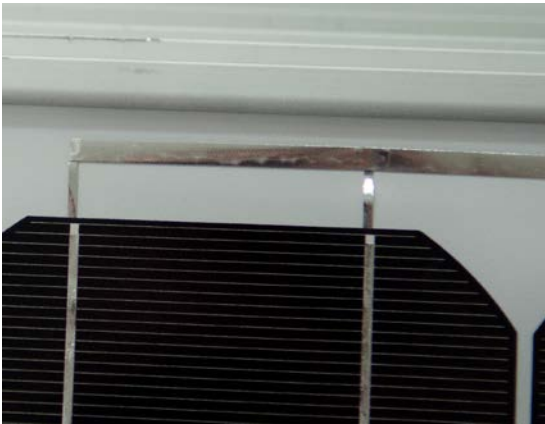
1.13 Busbar oxidation and discoloration

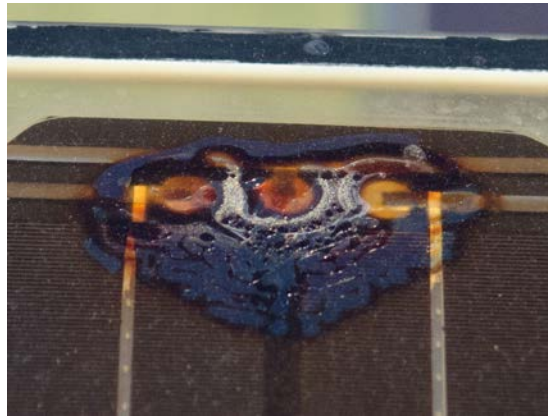
1.14 Busbar oxidation and discoloration

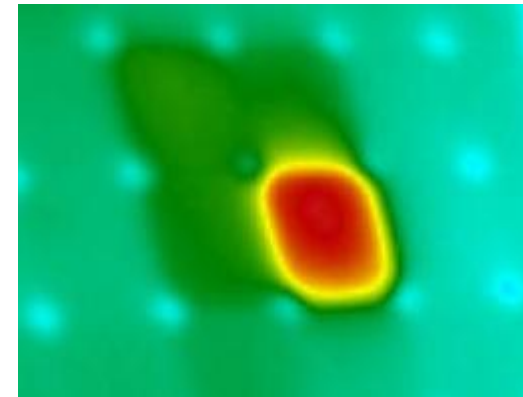
Hot spots appear when a solar cell within a module generates less current than the string current of the module. That happens when the cell is shaded, damaged or electrically mismatched [23]. Hot spots can be attributed to the properties of the solar cell like local shunts, deformations of the p–n junction, impurities, wafer resistance or other processing problems [24].

1.15 Hot spots (hot cells)

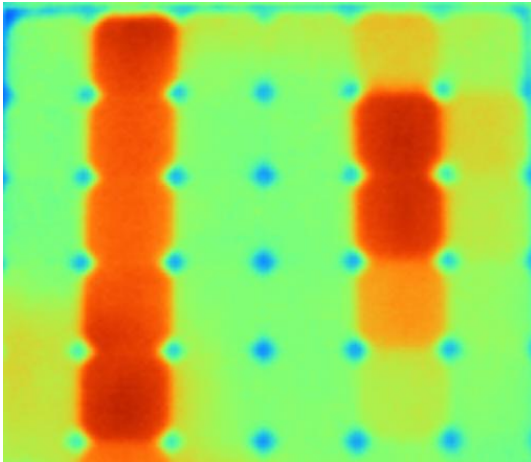
1.16 Hot strings

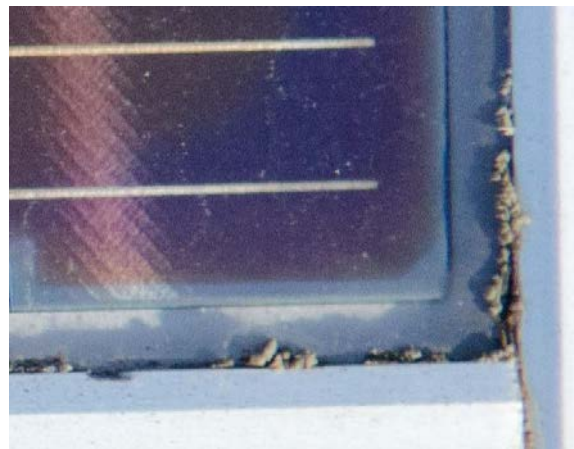
1.17 Sealant infiltration

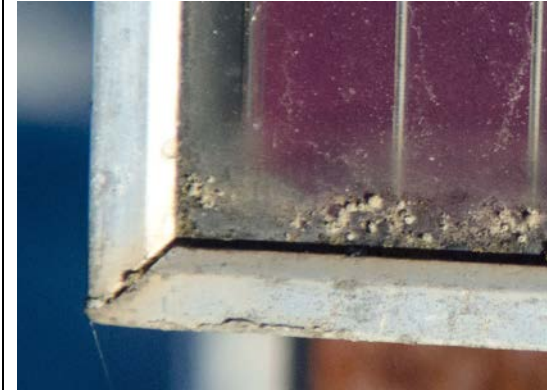
1.18 Insufficient stability of frame

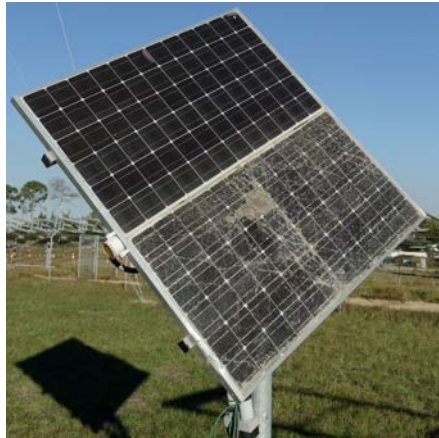
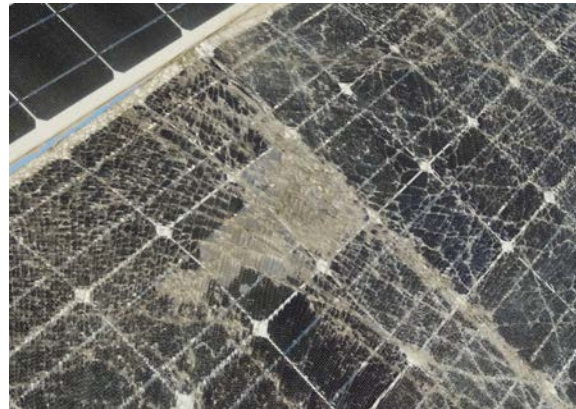
Some modules measured in this study had been exposed to severe physical impacts. These had resulted in wide scale breakage of the glass on the module's surface. These fairly extreme examples are likely to have been caused by weather, mishandling upon relocation, major thermal expansion mismatches or acts of vandalism. These cases of damage can be seen in Table 1 (1.19 and 1.20).

1.19 Physical impacts (fracture, glass breakage)

1.20 Physical impacts (fracture, glass breakage)

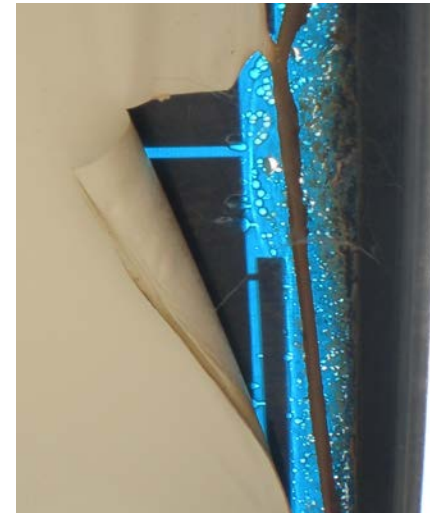
1.21 Delamination of the back polymer

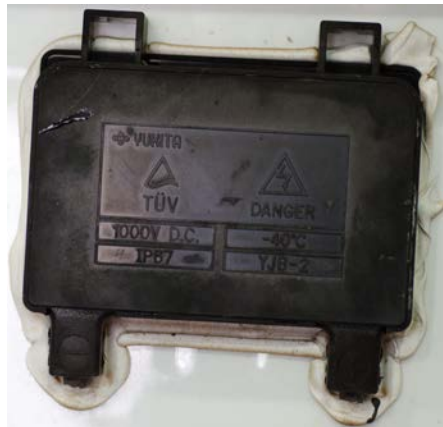
1.22 Junction box corrosion

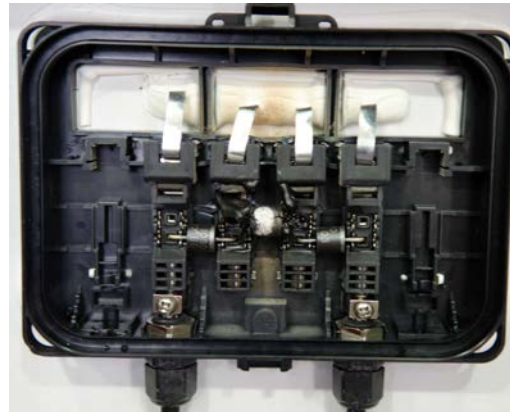
1.23 Damaged diodes

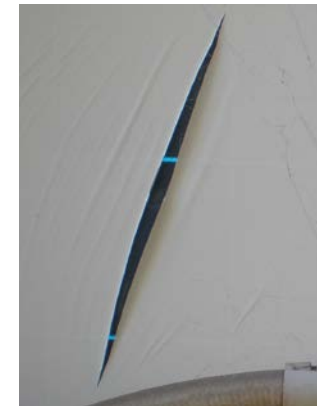
1.24 Back sheet polymer cracks

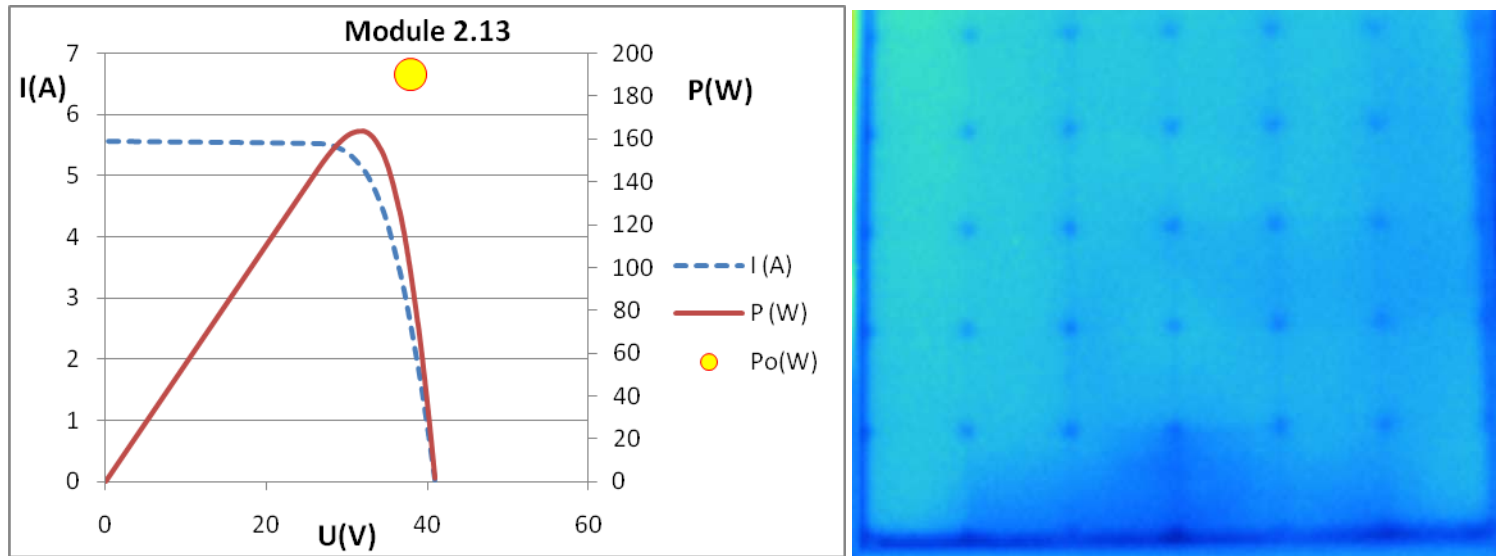
Figure 1 – A module with small degradation in power ( $P_m$  from  $190 W_p$  to  $165 W_p$ ) and no IR signs of hot spots

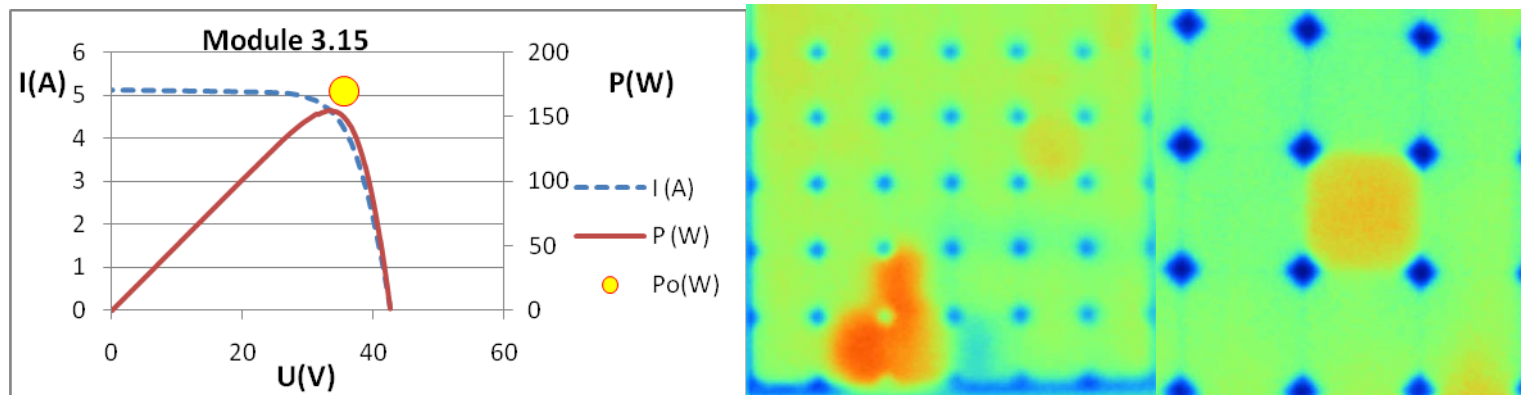
Figure 2 – A module with a small degradation in power ( $P_m$  from  $170 W_p$  to  $155 W_p$ ) and first IR hot spots

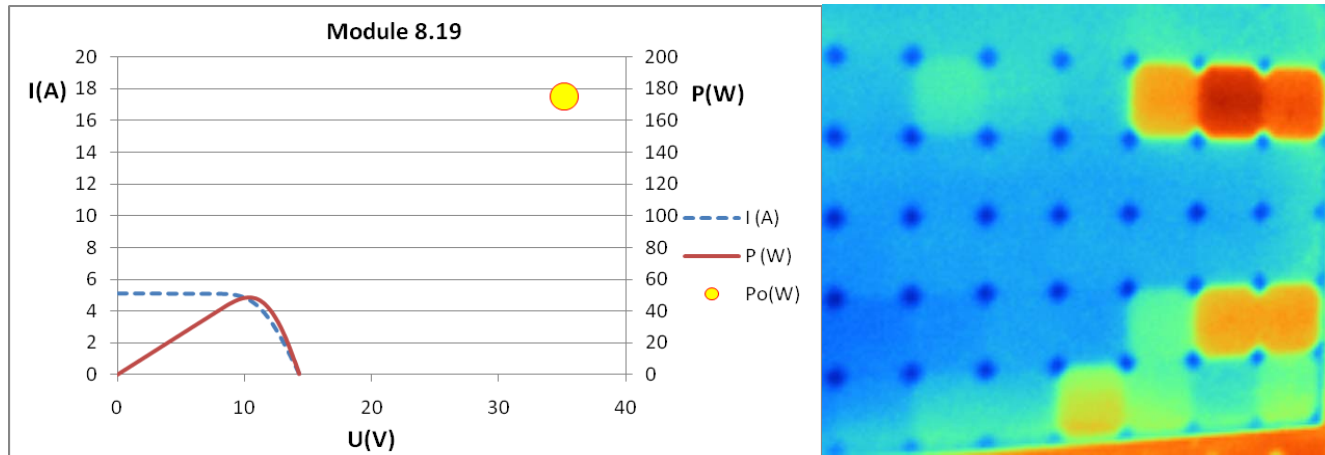
Figure 3 – A module with significant degradation (practically failed) in power ( $P_m$  from 175  $W_p$  to 50  $W_p$ ) and different IR hot spots

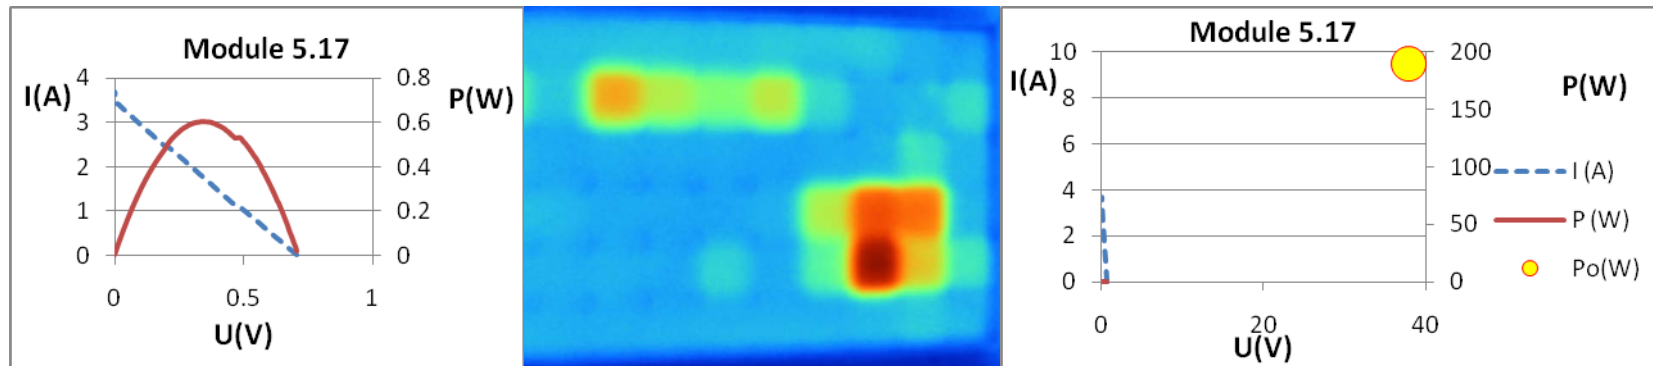
Figure 4 – A module with complete failure in power ( $P_m$  from 190  $W_p$  to 1  $W_p$ ) and IR hot spots of failed solar cells
